# Manhole Inspection Summary

Manhole # S23M\_\_028MH

Insp Date: **6/17/08 2:52 PM**

**Location** Address: **403 S Gilmor St**

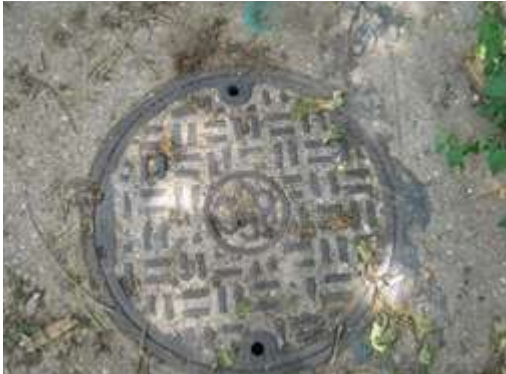
Misc-4

MH Cover

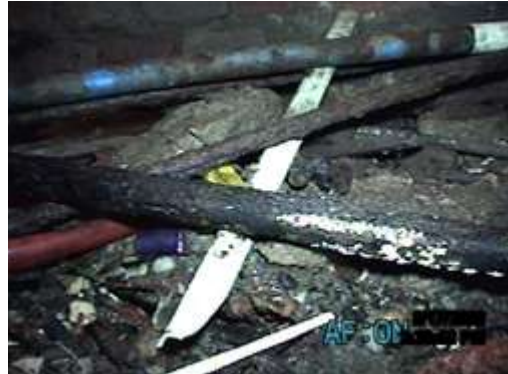
Defect 4

Condition: ☐ Sound ☐ Cracked ☐ Root Intrusion ☐ Deteriorated ☐ Leaks ☒ **Debris**

Channel debris

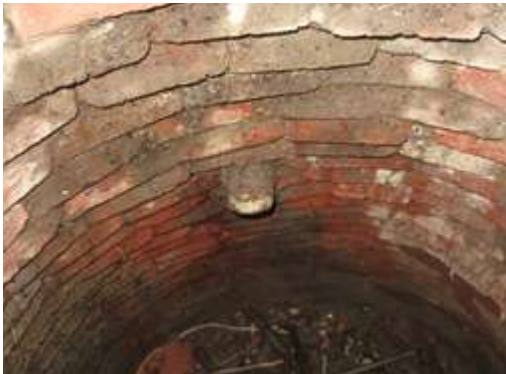
Defect 3

Infiltration: ☐ None ☐ Joint ☐ Cracks ☒ **Mortar** ☐ Roots ☐ Wall

infiltration in corbel at mortar

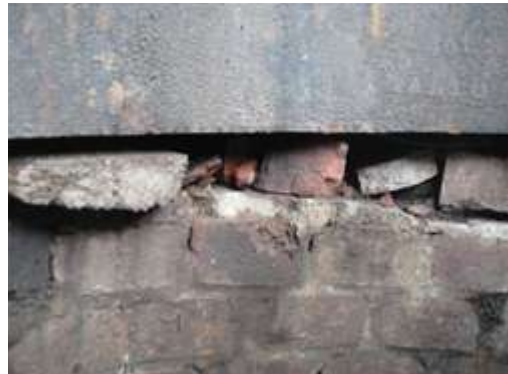
Defect

Condition: ☐ Sound ☐ Cracked ☐ Root Intrusion ☒ **Loose Brick** ☒ **Deteriorated**

chimney loose bricks

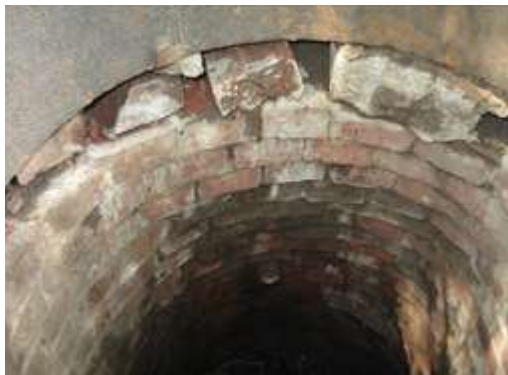
Defect 1

**Frame** Offset: **0** (in.) Condition: ☐ Sound ☐ Cracked ☒ **Leaks**

Infiltration: ☐ None ☒ **Joint** ☐ Cracks ☒ **Mortar** ☐ Roots ☐ Wall

frame leaks, chimney loose brick & deteriorated with infiltration at joint

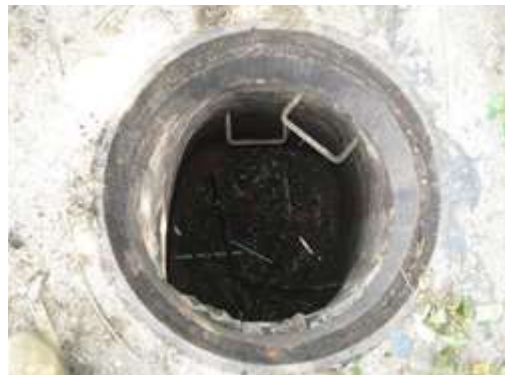
Defect

Frame leaks

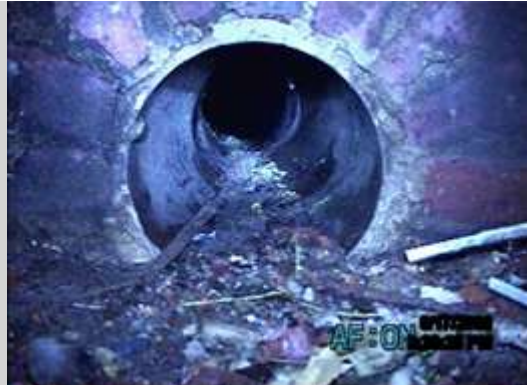
12 O'Clock Outflow

8 in. Circular Gravity Sewer  
Pipe Out @ 12 O'Clock

Pipe Height: **8.4** (in.) Rod and Bar (Angled)

Pipe Material: **Clay** ☐ Pipe Lined

Invert Depth: **6.80** (ft.) Flow Characteristics: **None**

Deposits: ☒ None ☐ Mud ☐ Sludge ☐ Debris ☐ Grease

Infiltration: **None** Pipe Seal Cond: **Sound**
